| WAAS<br>CH <b>42938</b><br><b>W18A</b> | APP CRS<br><b>179°</b> | Rwy Idg <b>5000</b><br>TDZE <b>55</b><br>Apt Elev <b>55</b> |

RNAV (GPS) Y RWY 18  
PICAYUNE MUNI (MJD)

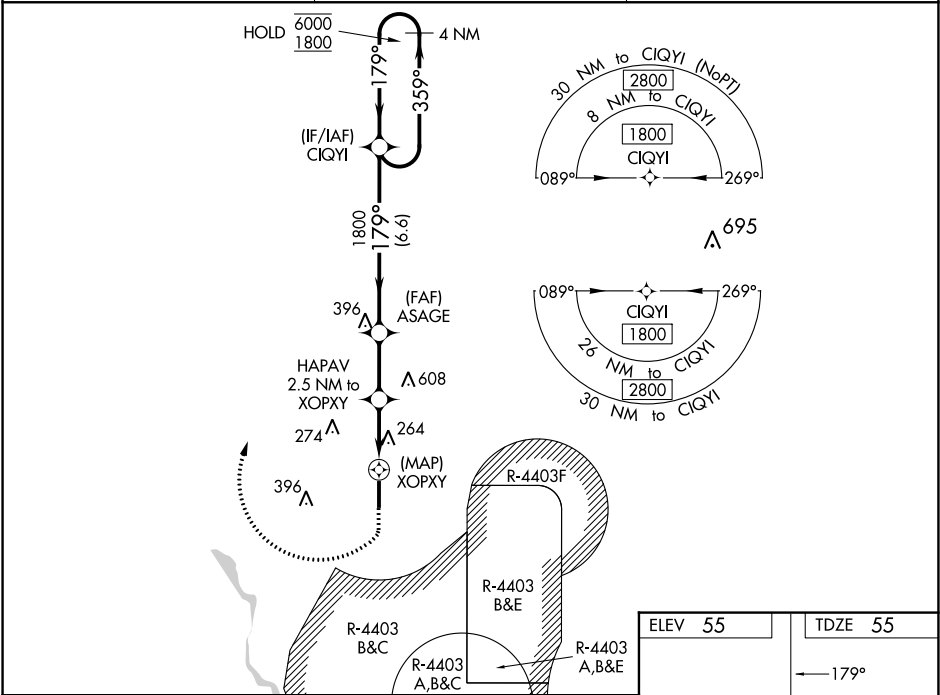
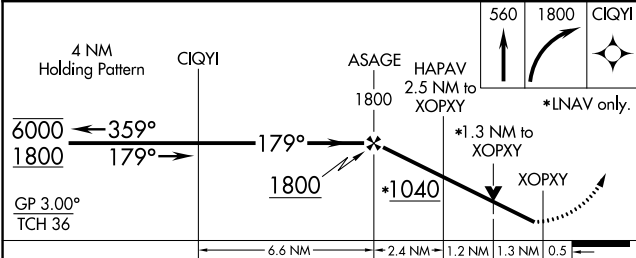
| RNP APCH.<br>Baro-VNAV and VDP NA when using Stennis Intl altimeter setting. Rwy 18 helicopter visibility reduction below 3/4 SM NA. For uncompensated Baro-VNAV systems, LNAV/VNAV NA below -15°C or above 5°C. When local altimeter setting not received, use Stennis Intl altimeter setting: increase LPV DA to 377 and visibility all Cats 1/2 mile; increase LNAV/VNAV DA to 621 and visibility all Cats 1/2 mile; increase all MDA 40 feet. Procedure NA when R-4403 B/C/E is active. | MISSED APPROACH: (Do not exceed 185K) Climb to 560 then climbing right turn to 1800 direct CIQYI and hold. |
