## KODIAK

**KODIAK** (ADQ)(PADQ) P (CG) 4 SW UTC-9(-8DT) N57°44.99' W152°29.64'

**KODIAK (LILLY LAKE) SPB** (9Z3) 1 NE UTC-9(-8DT) N57°48.16' W152°22.96'

**KODIAK MUNI** (KDK)(PAKD) 2 NE UTC-9(-8DT) N57°48.36' W152°22.43'

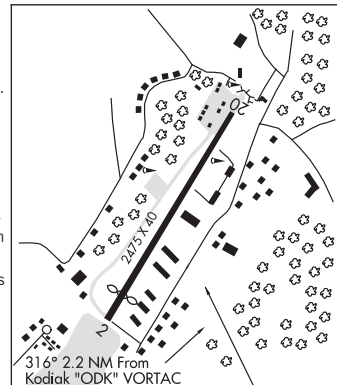
**RWY 02-20:** H2475X40 (ASP-TRTD)

**RWY 02:** Thld dsplcd 240'. Tree. Rgt tfc.

**RWY 20:** Trees.

surrounded by numerous businesses in close proximity. Rwy 02-20

pavement width varies from 20' wide on Rwy 20 end to 30' wide on

Rwy 02 end. Pavement is cracked length of rwy. Rwy 20 road crosses

apch 15' blo thld elev 200' from rwy thld. Rwy slopes uphill 67' from

Rwy 02 dsplcd thld to Rwy 20. Rwy 02-20 NSTD markings faded to

invisible, no line of sight between rwy ends. First 350' of Rwy 02 slopes

5% uphill.
