DOUGLAS MUNI (DGL)(KDGL) 2 E UTC-7 N31°20.56' W109°30.39'
 4173 B AOE NOTAM FILE PRC
RWY 03-21: H5760X75 (ASPH) MIRL
RWY 03: PAPI(P4L)—GA 4.0° TCH 40'. Brush. Rgt tfc.
RWY 21: PAPI(P4L)—GA 4.0° TCH 50'. Brush.
RWY 18-36: 4095X100 (DIRT)

PHOENIX
H-4K, L-5D

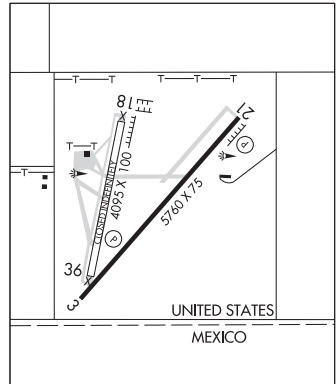
RWY 18: Brush.
RWY 36: Brush. Rgt tfc.
SERVICE: FUEL 100LL, JET A LGT Dusk-dawn. PAPI Rws 03 and 21
 OTS indfly.

AIRPORT REMARKS: Attended Mon-Fri 1300-2200Z, For svc after hours
 call 520-368-6015. Personnel on ATVs near acft opr
 areas-unrestricted. Mountains 1 1/2 miles east. 24 hr 100LL avbl
 with major credit card. Rwy 03-21 has 1"- 6" cracks across rwy. Rwy
 18-36 has +4' brush, rocks and uneven surface for 3/4 of rwy
 length. Rwy 21 50' twr 1350' from thld 550' left lgtd. Rwy 18-36
 brush on both sides 70 ft from centerline full length of rwy. Rwy
 18-36 surface rough and rutted. Rwy 18-36 +3 ft bump 300 ft from
 Rwy 18 thld. Rwy 18-36, 2 ft bump crossing twy to Rwy 03-21.
 Flight notification svc avbl.
