**JIM HAMILTON L B OWENS** (CUB)(KCUB) P (AR) 2 S UTC-5(-4DT) N33°58.23' W80°59.72'

**RWY 13-31:** H5011X75 (ASPH) S-44.5, D-66 PCN 15 F/B/X/T MIRL

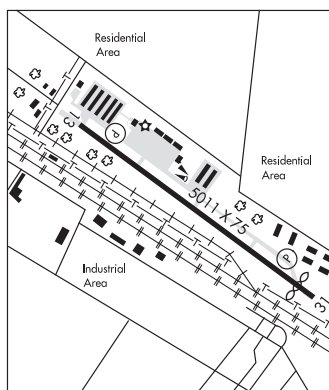
**RWY 13:** REIL. PAPI(P2L)—GA 4.0° TCH 30'. Tree. Rgt tfc.

**RWY 31:** REIL. PAPI(P2R)—GA 3.0° TCH 20'. Thld dsplcd 391'. Tree.
