MC DERMITT STATE (26U) 0 W UTC-8(-7DT) N42°00.62' W117°43.63'

MC KENZIE BRIDGE STATE (ØØS) 3 E UTC-8(-7DT) N44°10.89' W122°05.13'

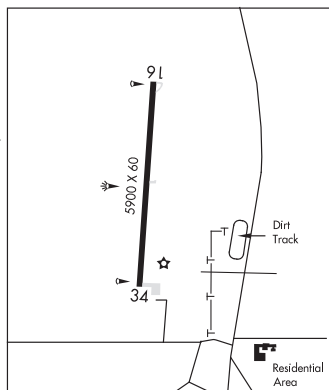
RWY 16-34: H5900X60 (ASPH) S-12.5 PCN 13 F/C/X/T MIRL

1.0% up N
